1680 in JAX

January 27, 2011

Jeff and Craig visit location

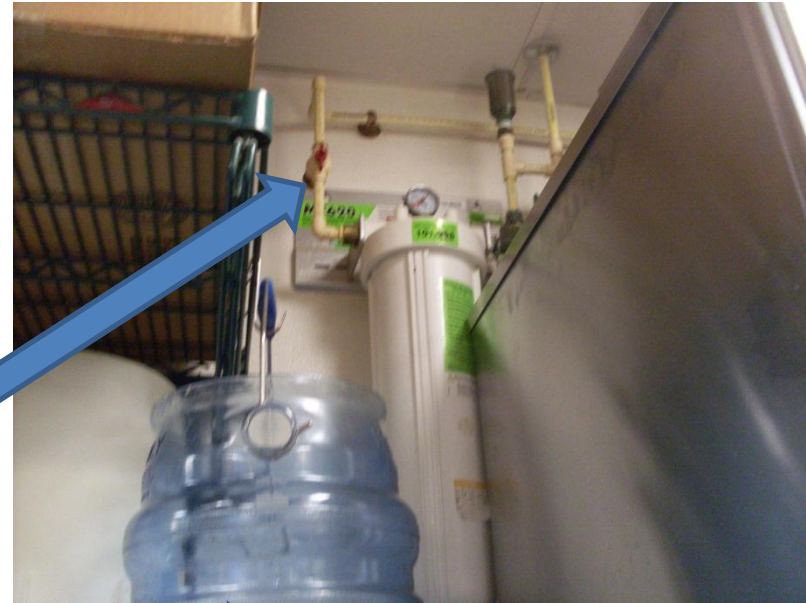
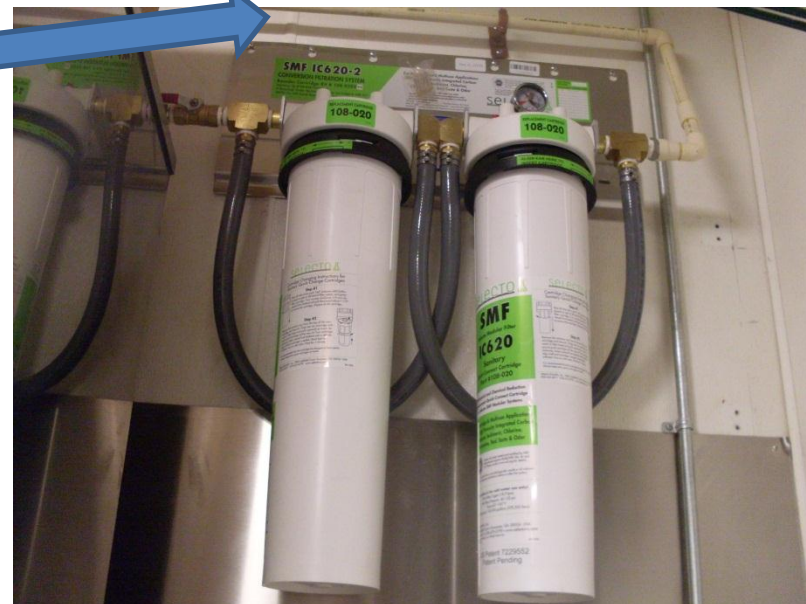
Ice machine filtration inspected by both of us

We found nothing wrong with it

No good pics above the ice machine, but I think this is the inlet for the teabrewer filter,

and it looks like that could be the same line that runs above and to the right of the ice machine filters.

If the ice machine filtration was plumbed backward, that would mean that we both missed this during our visit there.

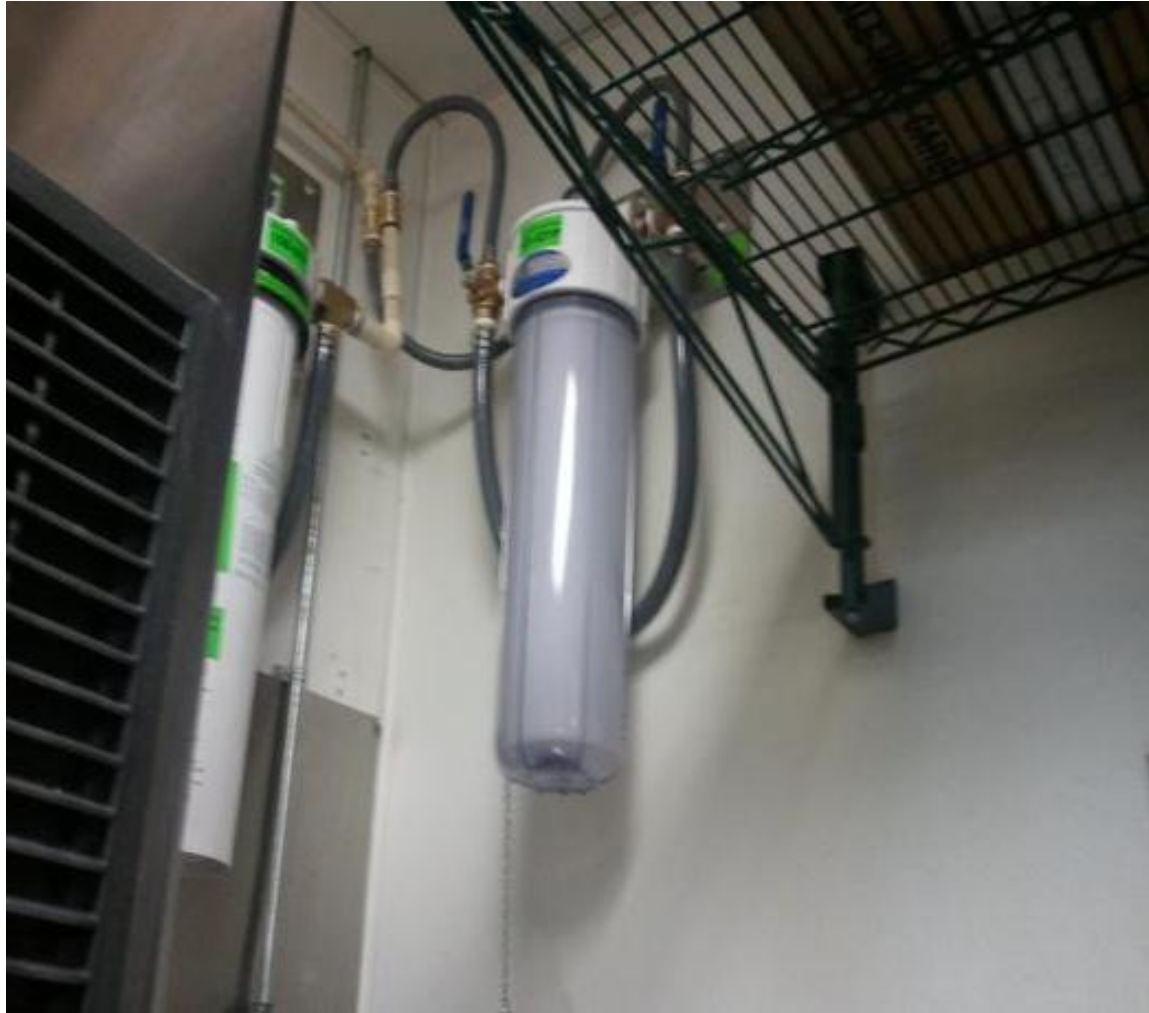
Wayne Anderson's company shows up and installs a prefilter on the ice machine-

Looks like he is prefiltering AFTER the SMFIC620-2 (if that is really the outlet side).

BUT.....if the SMFIC620-2 is plumbed backward, then Wayne plumbed the prefilter backward, too (in the outlet, out the inlet)

I think the plumbing for the filtration was correct, and Wayne goofed up the prefilter installation.

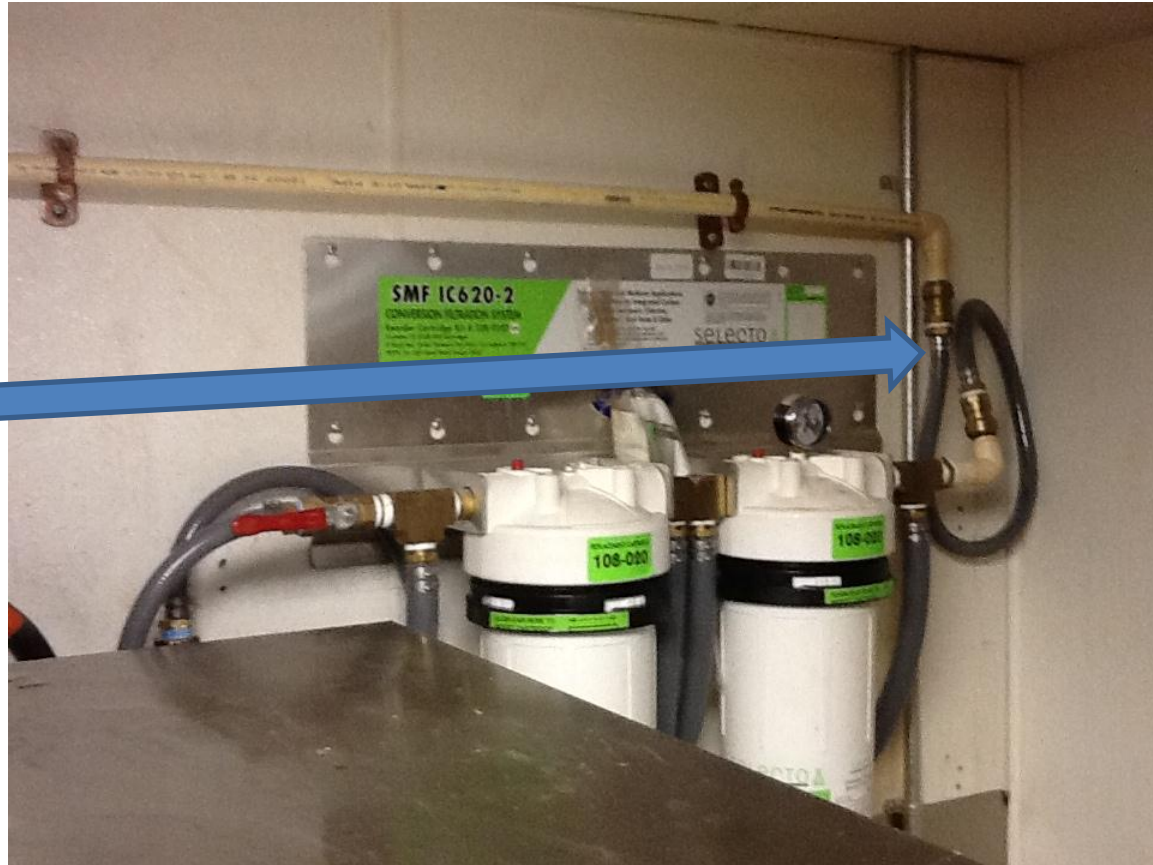
PB&J shows up and reports that the ice machine filtration is backward. They are instructed to correct this and remove the prefilter.

They eliminated the prefilter and looped back with Accuflex.

But the right side of the filters are still going to the same tubing as before.

I think once they saw the plumbing, it **was** plumbed correctly, and then they only had to eliminate the prefilter to make it correct.
